# AEROSPACE INFORMATION REPORT

AIR4092

## INVESTIGATION OF PTFE "MELT" PHENOMENON FOR HIGH PRESSURE HOSES

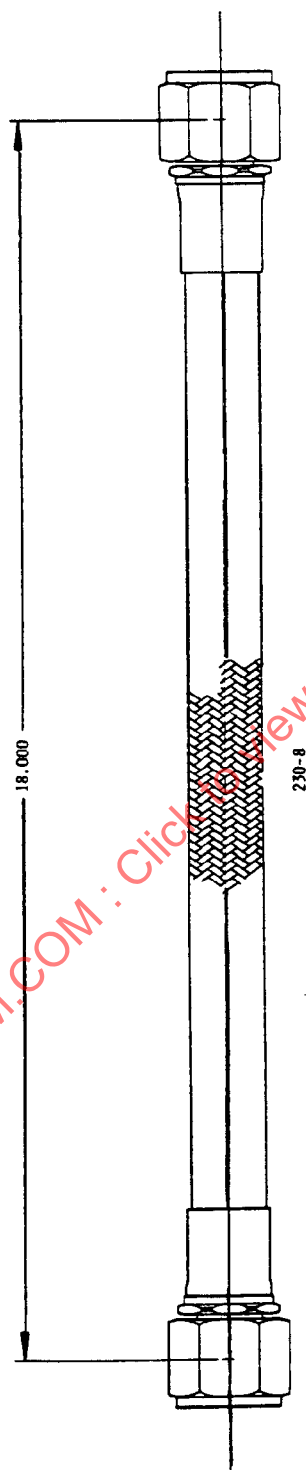
FIGURE 1

1. 18 in long, "230" Series, -8 size assemblies using straight to straight flared fittings. This is the lightweight, high pressure hose (see Fig. 1). Conforms to AS1339 and AS115 (bare hose) and MIL-H-38360.
2. 18 in long assembly is identical to sample 1, except it has an integral silicone firesleeve (see Fig. 2). Conforms to AS1339 and AS115 (integral firesleeve) 15 min and MIL-H-38360.
3. 18 in long assembly, "660" Series, -8 size assemblies using straight to straight flared fitting. This is the heavy duty spiral-wrapped, high pressure hose (see Fig. 3). Conforms to AS 604 and AS 621 (bare hose) and MIL-H-38360.

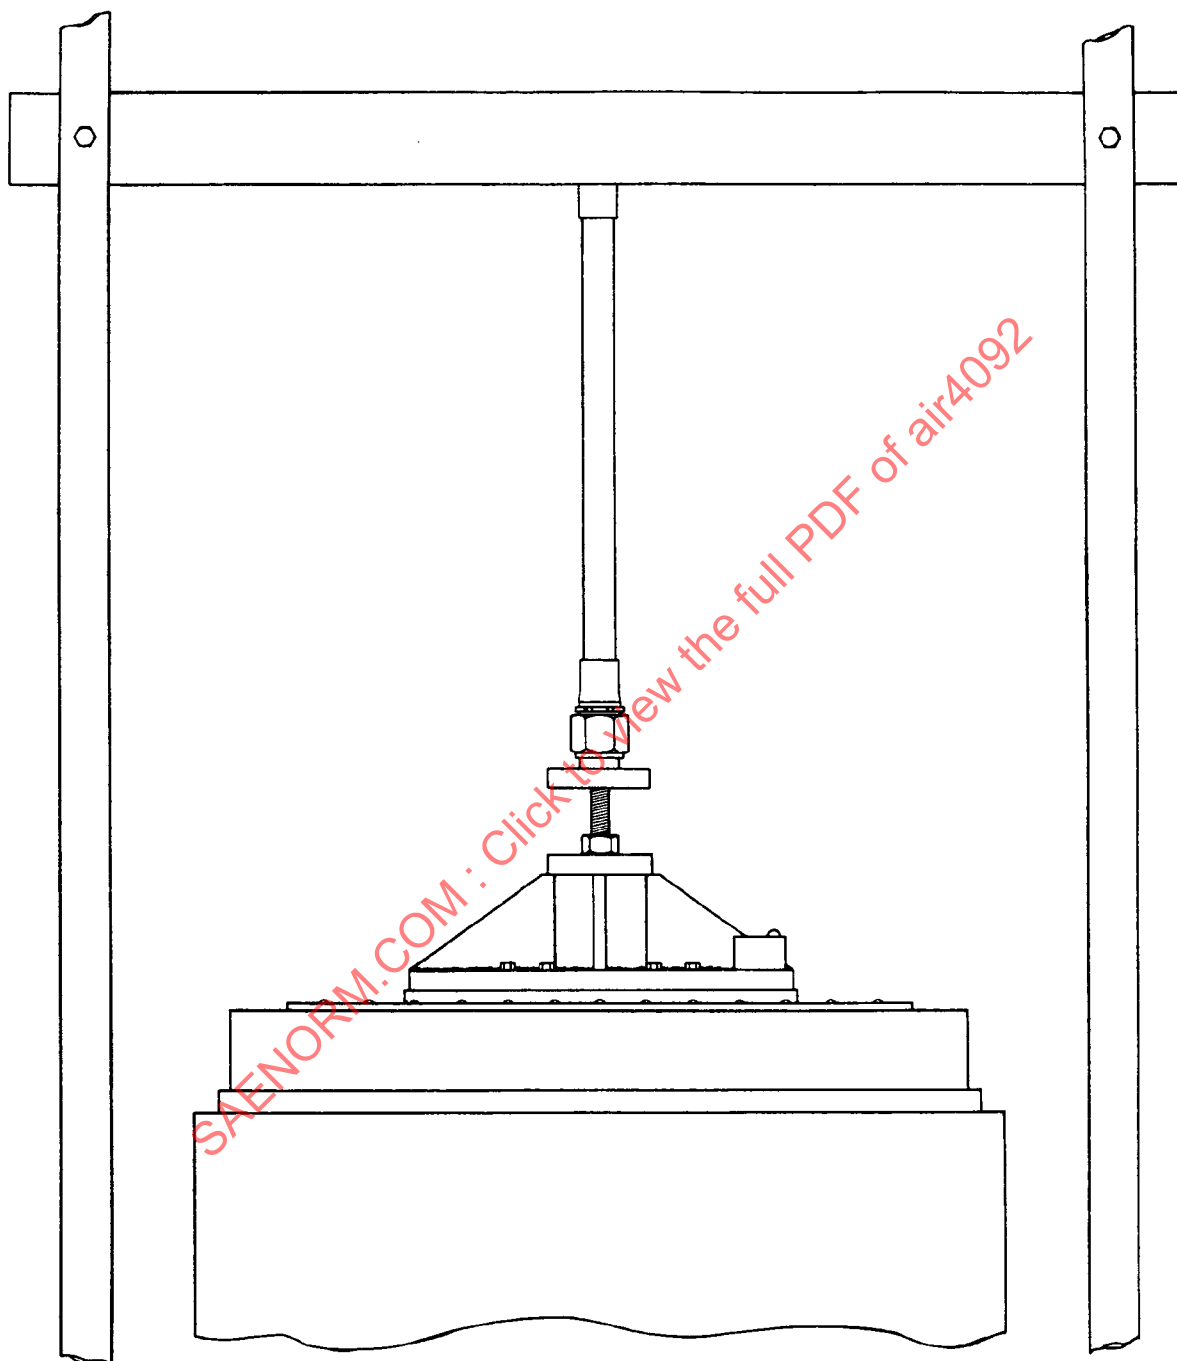
FIGURE 4

The specimens were installed in a vertical attitude and essentially in a straight position. The bottom fitting was attached to the top of an MB shaker table. The top fitting was attached to a fixed terminal with a pressure supply. The hose was filled with water at 3000 lbf/in<sup>2</sup> throughout the test.

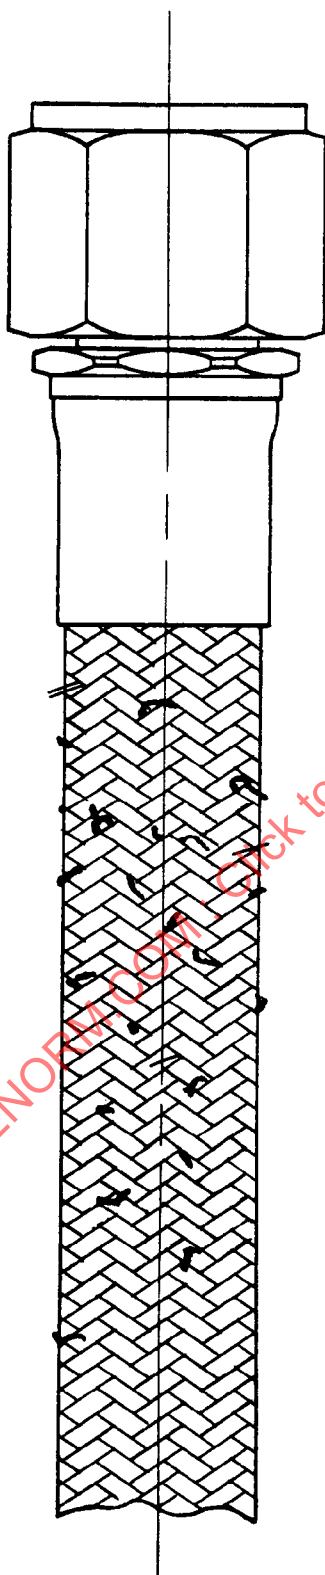
FIGURE 5

1. Bare "230" series, lightweight hose assembly showed heavy Teflon extrusion of PTFE through the braid and some broken braid externally and major deterioration of the innercore internally (see Figs. 5 and 6).
2. The "230" series, lightweight hose with integral firesleeve showed light extrusion of PTFE through the braid and some broken braid externally and major deterioration of the innercore internally (see Figs. 7 and 8).
3. The "660" series showed no extrusion of PTFE through the braid but did have broken wires externally, and it showed deformation of the innercore but no heat deterioration of the PTFE internally (see Figs. 9 and 10).

230-8  
21.3 Hz 16 g  
FAILURE 20 MIN

For hose assembly applications where the hose can be subjected to applied or induced vibration with high displacements along the axis of the hose, use the heavy duty spiral-wrapped type of hose. One typically critical application is the pump discharge hose for main and auxiliary pumps on aircraft. When the application requires an integral firesleeve to meet fire resistance of TSO or AS specifications, consideration can be given to the use of the lightweight hose and firesleeve combination as the most cost effective solution, provided the axial component of the vibration to be experienced does not exceed 0.200 double amplitude for an 18-in length of hose.
